# Chapel Allerton

## CONSERVATION AREA APPRAISAL & MANAGEMENT PLAN

Approved 22 October 2008

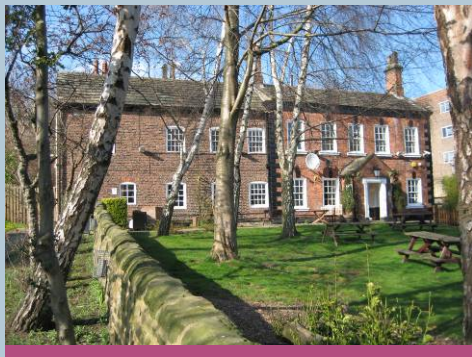
The Mustard Pot (formerly Clough House), Stainbeck Lane. Early 18th century in appearance, but with an earlier core. Although much of its interior has been lost, it retains two 18th century fireplaces.

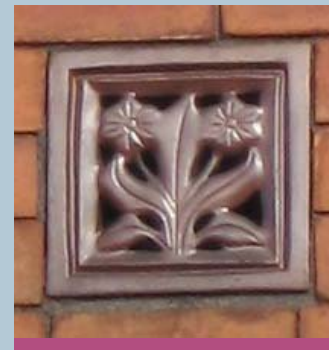
An air brick manufactured by the Leeds Fireclay Company of Burmantofts, an example of the decorative detailing to be found in the Methleys.

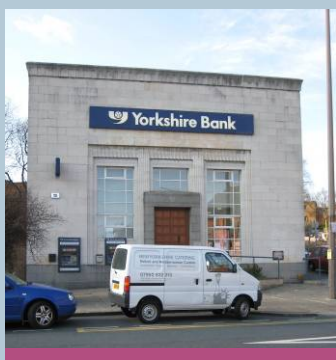
Yorkshire Penny Bank building, Stainbeck Corner. Built in the late 1930s, this small building is a good example of the stripped-down Classicism of Modern architecture between the wars.

the growing number of car-owners; the façade of Kwik-Fit on Harrogate Road dates from this period. On Stainbeck Corner, an extension to the rear of Club Row created a small row of very stylish shops facing the junction and in 1938 a branch of the Yorkshire Penny Bank was opened in a new building of considerable architectural quality.

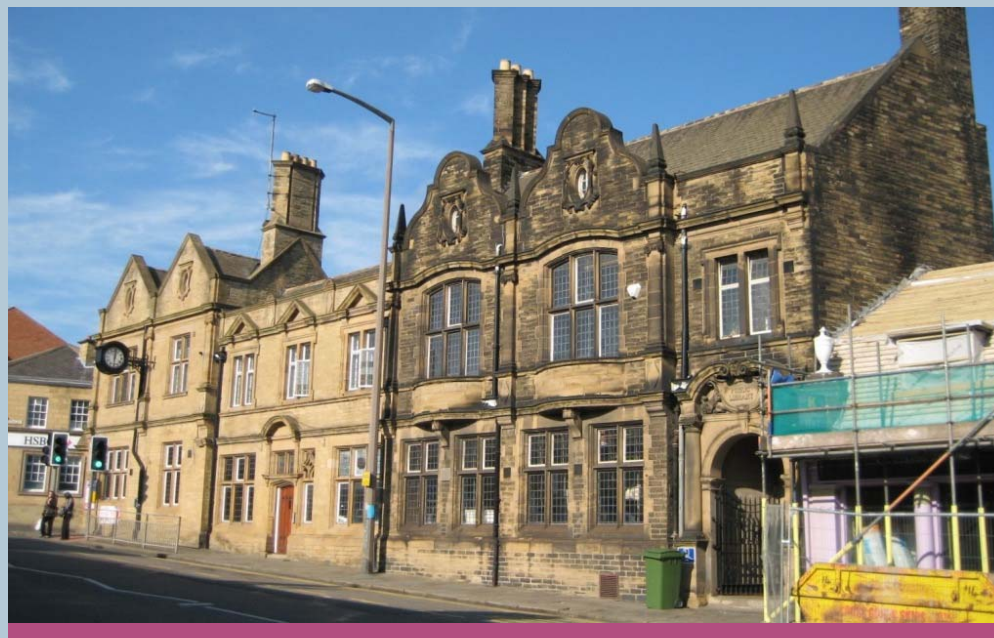
Two-storey sandstone buildings in the centre of Chapel Allerton.

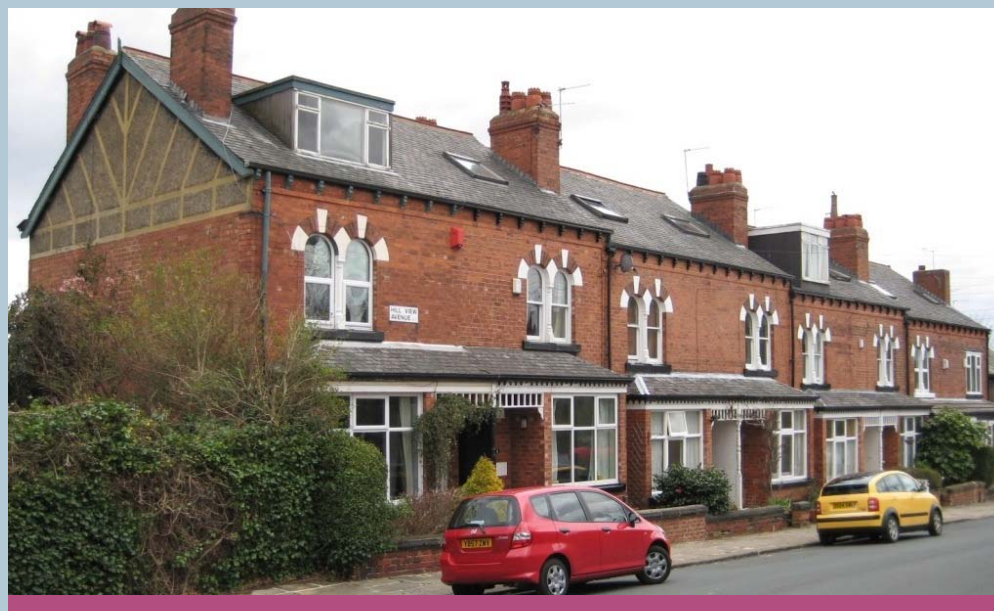
Brick terrace with repetitive decorative patterns giving unity to the row.

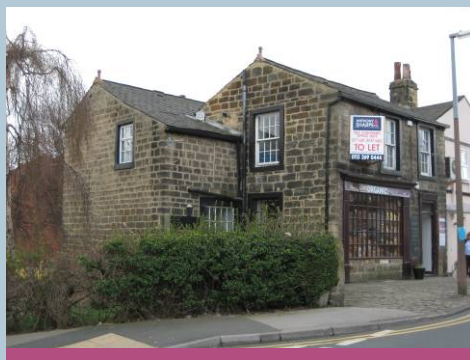
4 Well Lane. The building is early 19th century in appearance, but the cellar shows evidence of a much earlier building on this site. The sandstone walls, slate roof and 16-pane sash windows are typical of this character area.

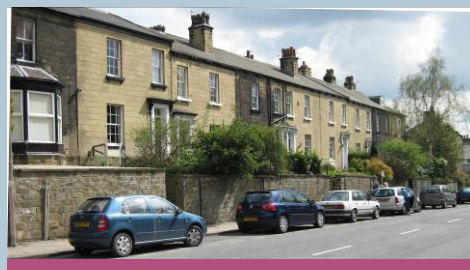
150-170 Harrogate Road. Also constructed of sandstone with a slate roof and 12-pane sash windows, the architectural character is rather different but the essential characteristics remain the same.

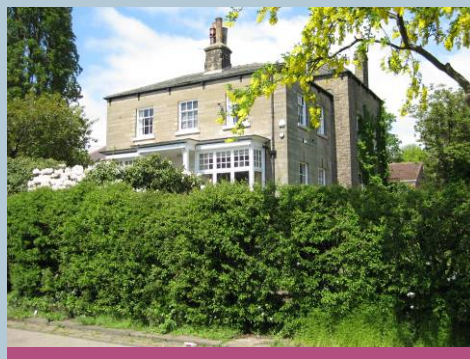
48 Henconner Lane. Set in moderately-sized gardens the house is of compact plan form with limited service accommodation, typical of a suburban villa.

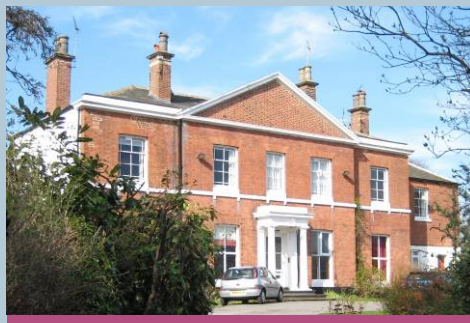
Rosemount, Henconner Lane. An imposing house of restrained Classical form, overlooking its south-facing gardens.

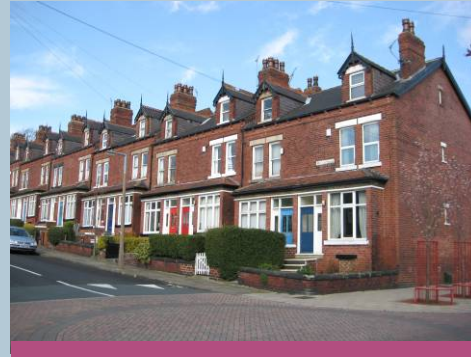
Methley Terrace. Note the slate-hung dormers with bargeboards and finials, decorative chimney pots and paired first floor windows.

Dormers are a prominent feature on late-19th century terraced housing, generally with slate-hung sides, decorative timber bargeboards and a timber gable finial. Some "Yorkshire" side-sliding sash windows survive and are a distinctive feature of the regional vernacular.

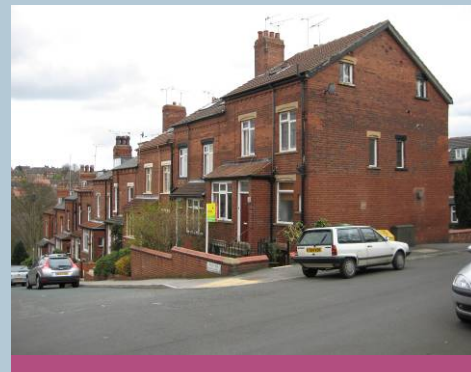
Pasture Crescent, a Type 3 back-to-back built between 1920 and 1934. Note the external basement access to the indoor lavatory and the very small larder window on the front elevation.

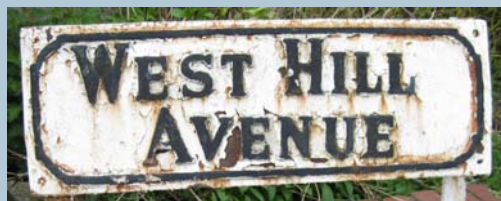
Other historic street signs have been allowed to fall into disrepair, such as the example below. Disrepair should not be used as an excuse for removal, but as an opportunity for enhancement. Stone street name signs are very unusual. They should be conserved in situ and not painted over or removed.

**Action:**  
Historic street name signs should be retained and conserved

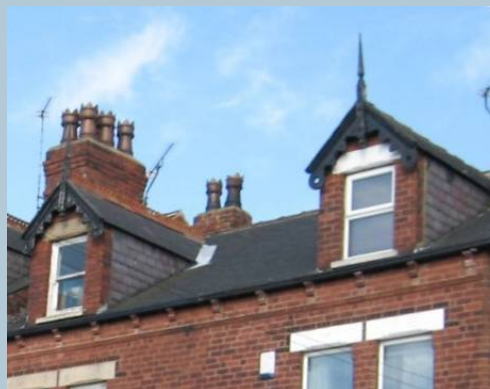
Dormers are a feature of the terraced housing in Chapel Allerton. While details vary in different streets, certain key features are common to all. New dormers in the conservation area are likely to require planning permission and any proposed new dormers on terraced housing in the conservation area should follow the design of nearby historic dormers.

Dormers have slate-hung sides, decorative timber bargeboards and gable finials. They are roofed in the same material as the rest of the building and are set immediately above a first-floor window, reinforcing the fenestration pattern of the terrace.

**Action:**  
New dormers in the conservation area should follow the design of original dormers on adjacent buildings

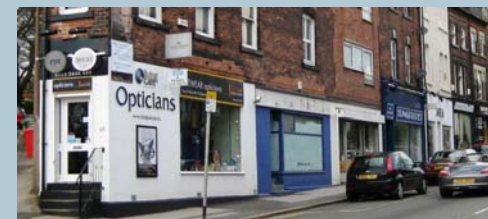
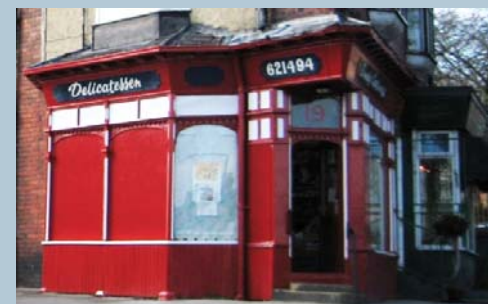
Shop front design can enhance the character of the area. New shop fronts should respect the proportions of the existing building and should usually be constructed of painted timber with flush lettering. Over-dominant fascia boards should be avoided. Internally-illuminated signs are not usually acceptable in a conservation area. The examples here show that good historic shop fronts enhance the character of the area as well as acting as an advertisement for the business, while poor or cluttered shop fronts do not encourage trade and mar the street scene.

**Action:**  
Guidance on shop front design in conservation areas should be produced.
