VERIFICATION REQUIREMENTS FOR COVER SYSTEMS

Technical Guidance for
Developers,
Landowners and
Consultants

**Yorkshire and Lincolnshire
Pollution Advisory Group**

Version 4.1 – June 2021

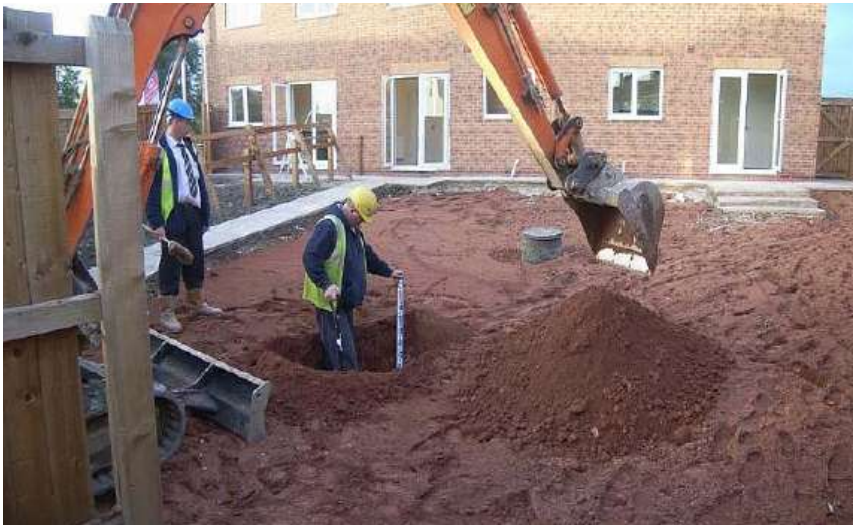
Photograph 11:
Shows the remediation of the rear garden, with a significant depth (1.0m) of inert cover. This photograph has been stitched to form a panoramic photograph and hence there is slight distortion

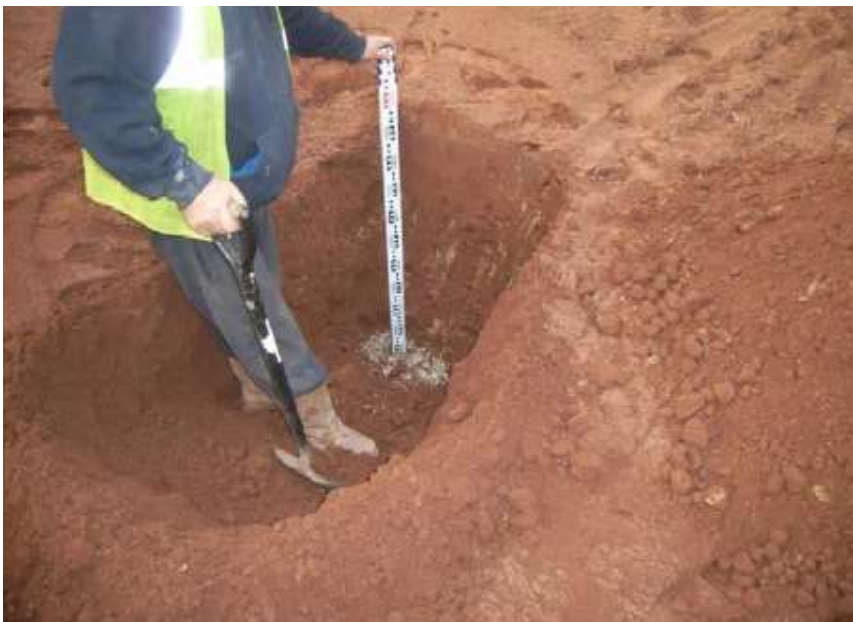
Photograph 12:
Shows the remediation of the rear garden, with a significant depth (1.0m) of inert cover. Remediation break layer visible at the base of the excavation.
